**Project Title:** Post Gold King Mine Spill: San Juan River Health Monitoring

**PI:** Dr. Abhishek RoyChowdhury

**Institution:** Navajo Technical University

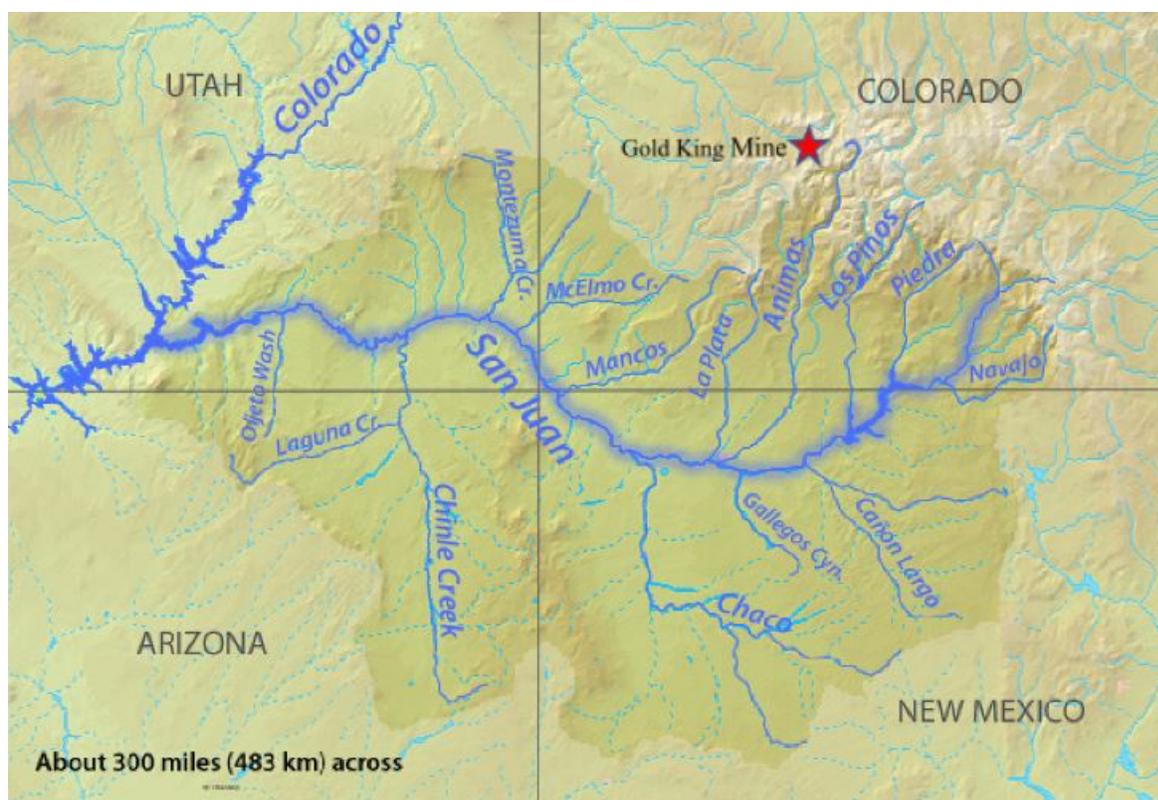
**Figure 1: The San Juan River portion of the Colorado River Basin. The red star indicates the site of Gold King Mine spill (Chief et al., 2016).**

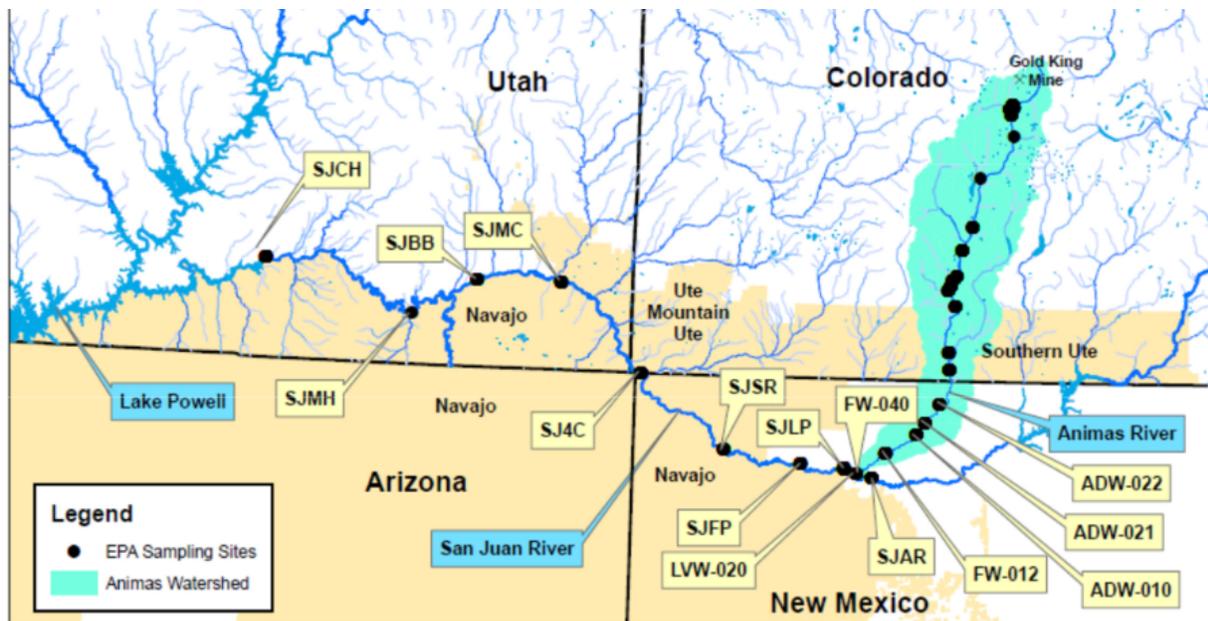
**Figure 3. US EPA sampling sites along the San Juan River**

The Navajo Technical University and FALCON research team selected four of the EPA sampling sites along the San Juan River for this study: SJAR, SJ4C, SJSR, and SJLP. SJAR is the EPA-designated “reference site” for the release incident. This sampling site is located immediately upstream of the Animas River confluence (SJAR) and was designated as the “reference site” because it would not have been subject to exposure of chemical inputs from the Gold King Mine spill. The other 3 study sites in the San Juan River were located downstream of the confluence with the Animas River in Farmington, NM (SJLP), Shiprock, NM (SJSR), and Four Corners, NM (SJ4C) (Figure 3). These sites were chosen because they are either: co-located with USGS stream gauges, are within the Navajo Nation, or are close to the Navajo Technical University campus.
